**MARYLAND HISTORICAL TRUST  
DETERMINATION OF ELIGIBILITY FORM**

Property Name: John Leister Farm Inventory Number: CARR-1686  
Address: 3036 Halter Road City: Union Mills Zip Code: 21158  
County: Carroll USGS Topographic Map: Littlestown  
Owner: Halter Road Farm LLC Is the property being evaluated a district? yes  
Tax Parcel Number: 67 Tax Map Number: 21 Tax Account ID Number: 008274  
Project: 239 Pleasant Valley Road Demolition/Carroll County Agency: Carroll County Department of Planning  
Site visit by MHT staff: X no yes Name: \_\_\_\_\_ Date: \_\_\_\_\_  
Is the property is located within a historic district? yes X no

## Maryland Inventory of Historic Properties Form

historic John Leister Farm

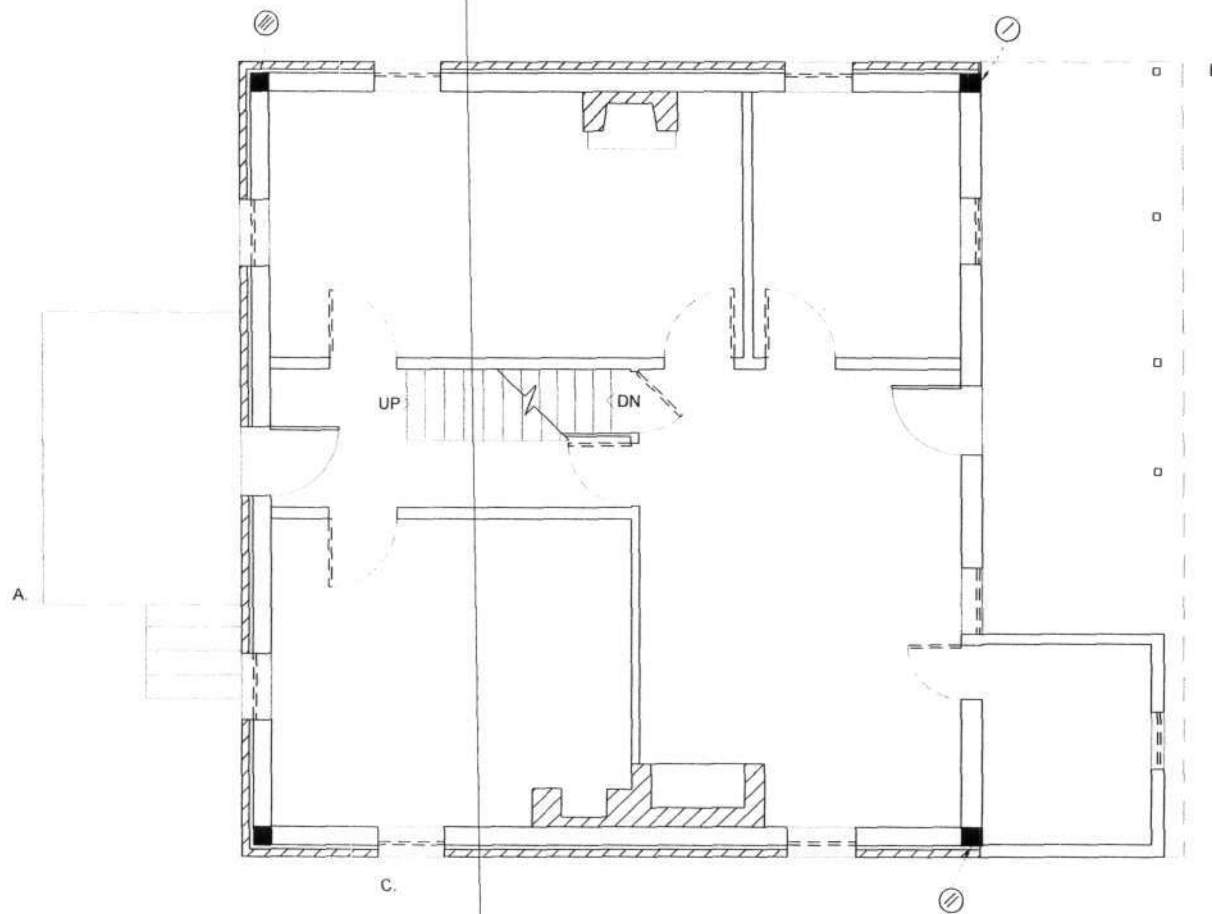
FIRST FLOOR PLAN MEASURED AND DRAWN BY KEN SHORT FEBRUARY 2004

A. MODERN CONCRETE PORCH AND STEPS. NO SURVIVING EVIDENCE OF ORIGINAL PORCH.

B. OUTLINE OF EXISTING ORIGINAL PORCH ROOF SHOWN. NEW CONCRETE PORCH DECK NOT SHOWN.

C. WINDOW SASH, MOST DOORS, AND STAIR BALUSTRADE PREVIOUSLY REMOVED. MOST OF BRICK CASING WAS REMOVED PRIOR TO EXAMINATION. BUILDING DISMANTLED FEBRUARY-MARCH 2004.

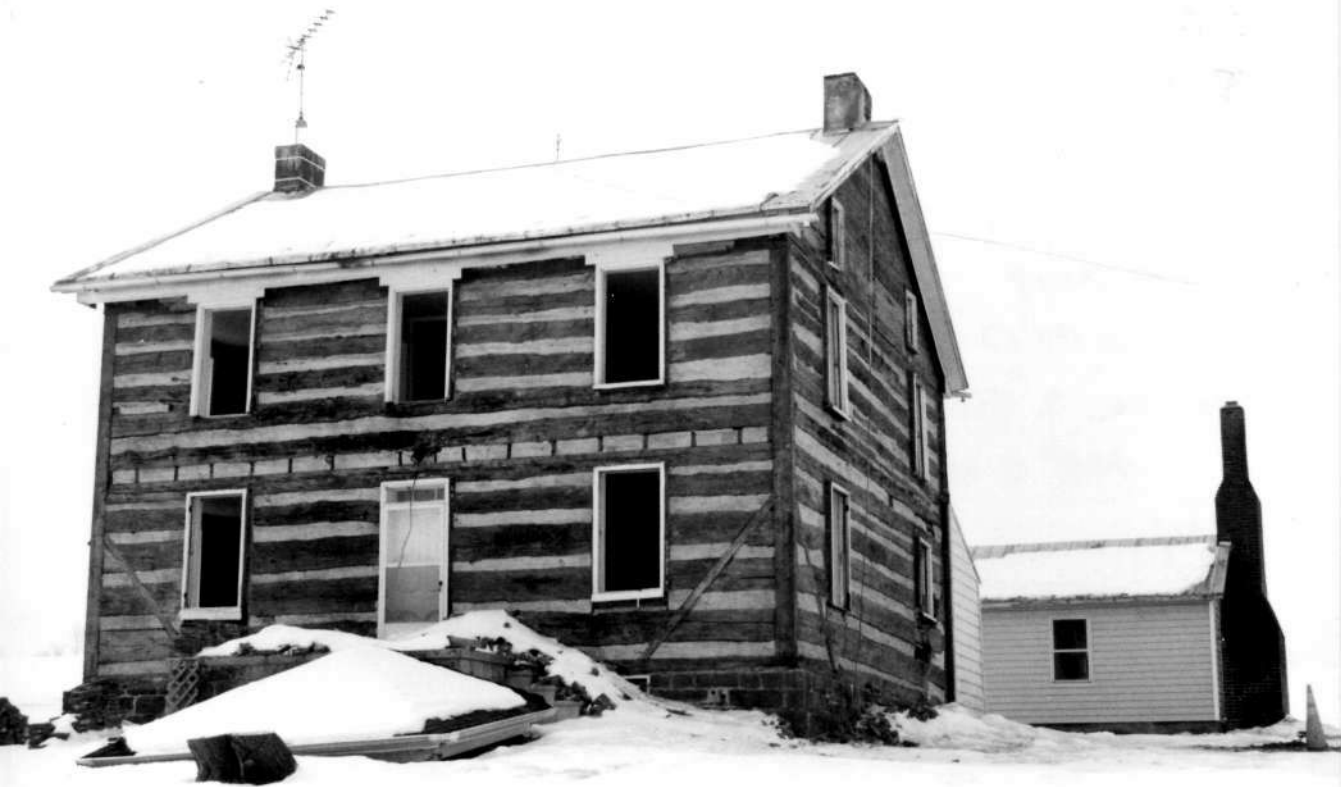
1/4

House & Summer Kitchen

NE & NW elevs

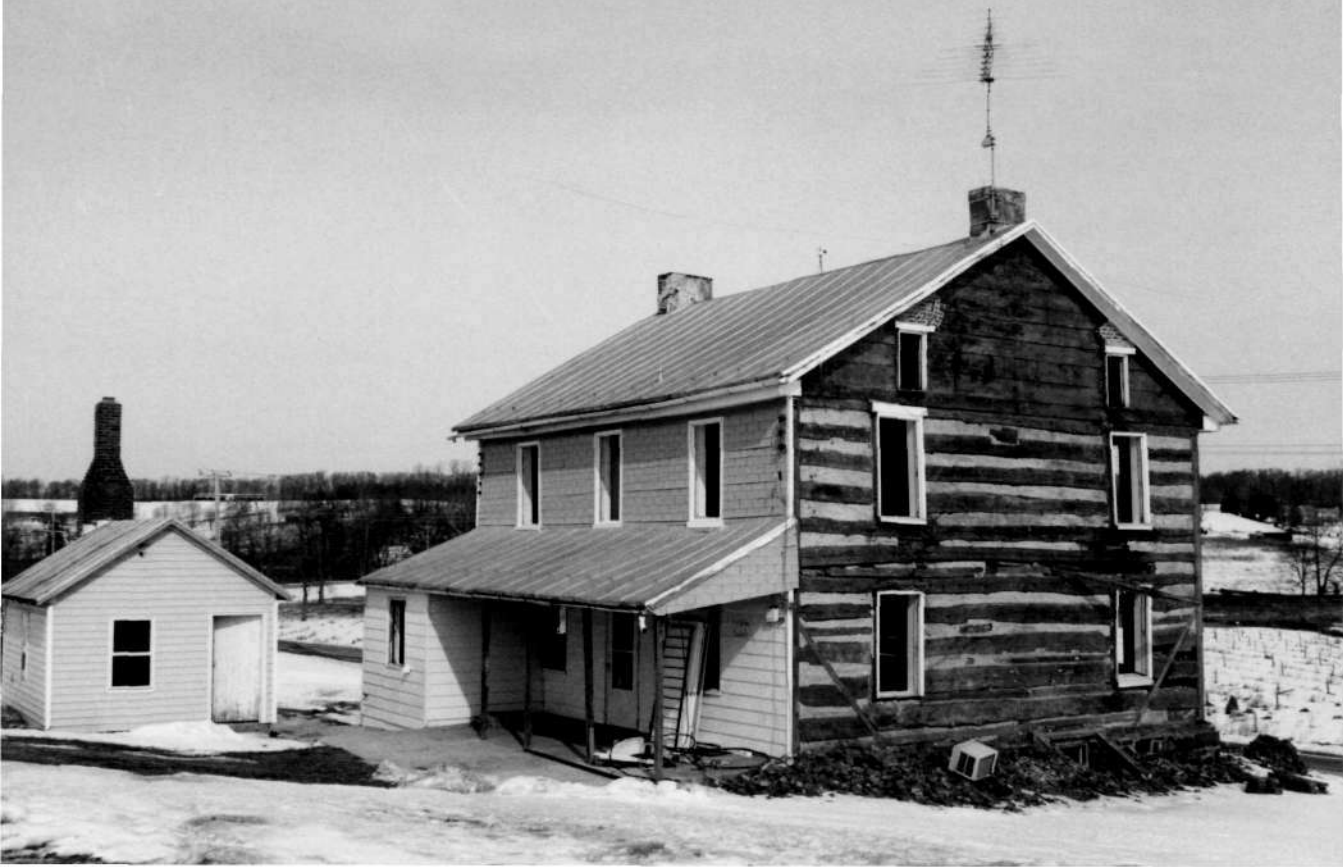
2/4

House & Summer Kitchen

SW & SE elevs

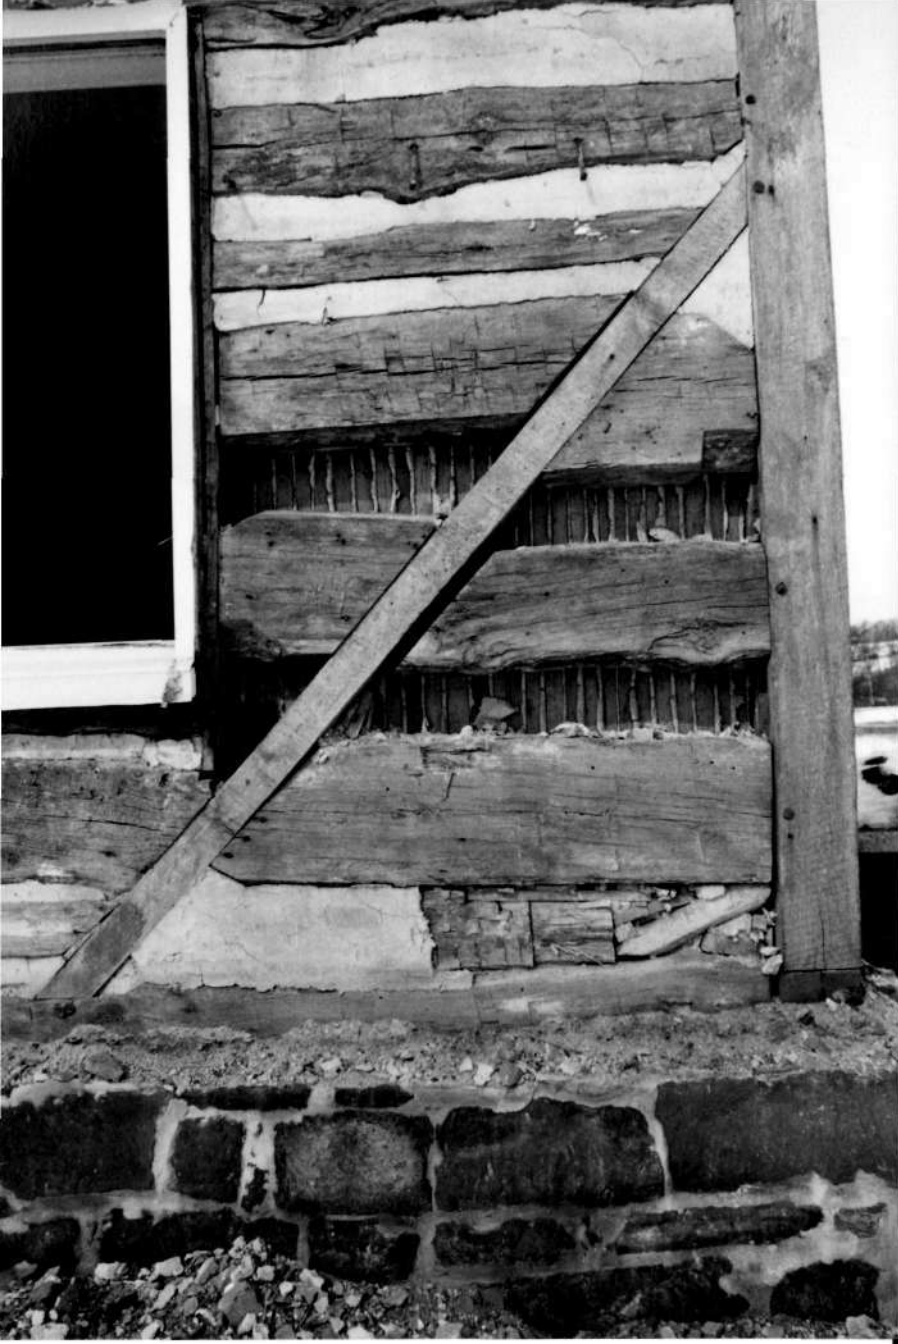
3/4

House - SE elev. - E. corner  
framing.

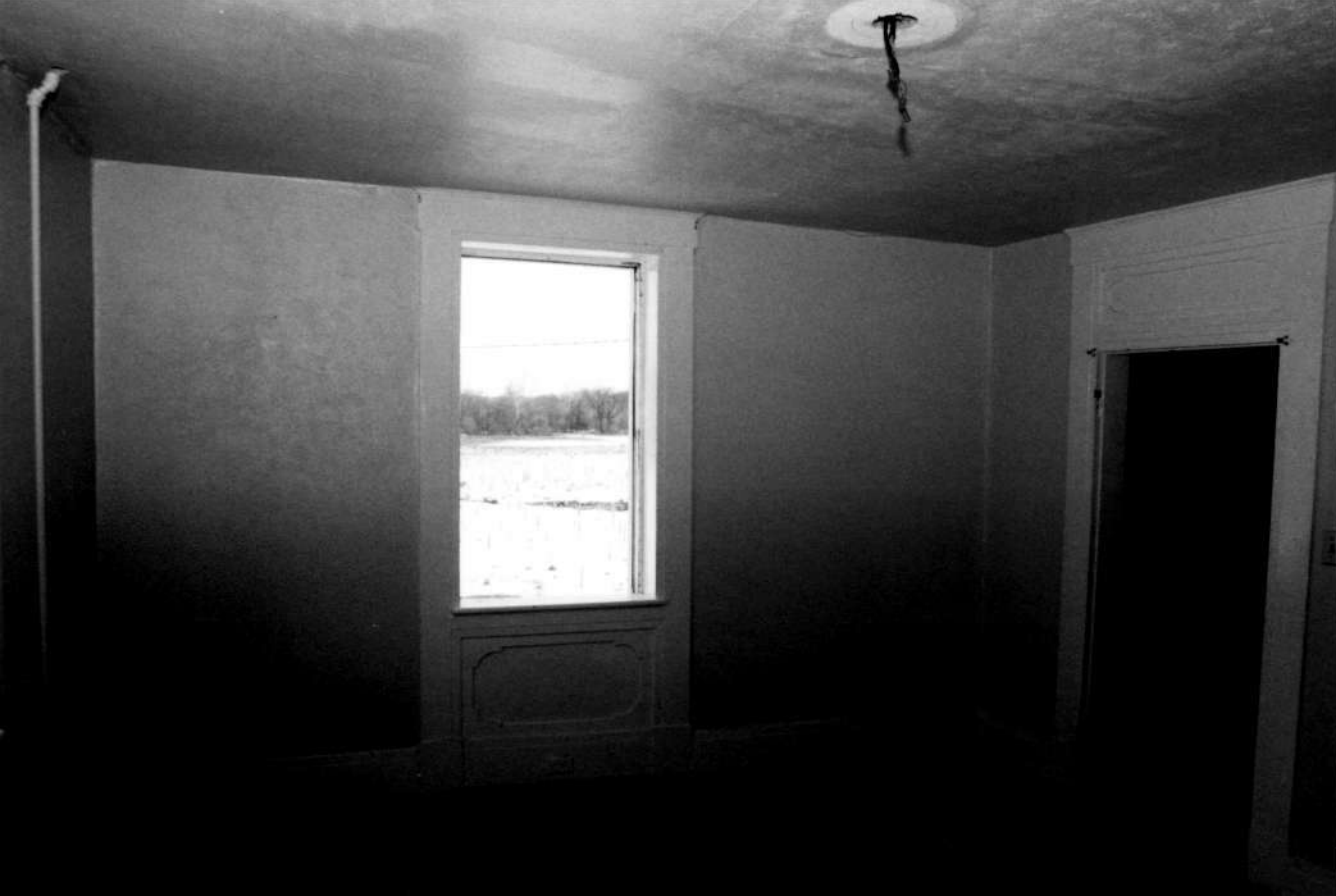
4/4

House - N. Rm, vw. E.
